NONDESTRUCTIVE ANALYSIS AND DEVELOPMENT

FINAL REPORT

Prepared for the
National Aeronautics and Space Administration
John F. Kennedy Space Center
Under Grant # NAG 10-0058

August 1993

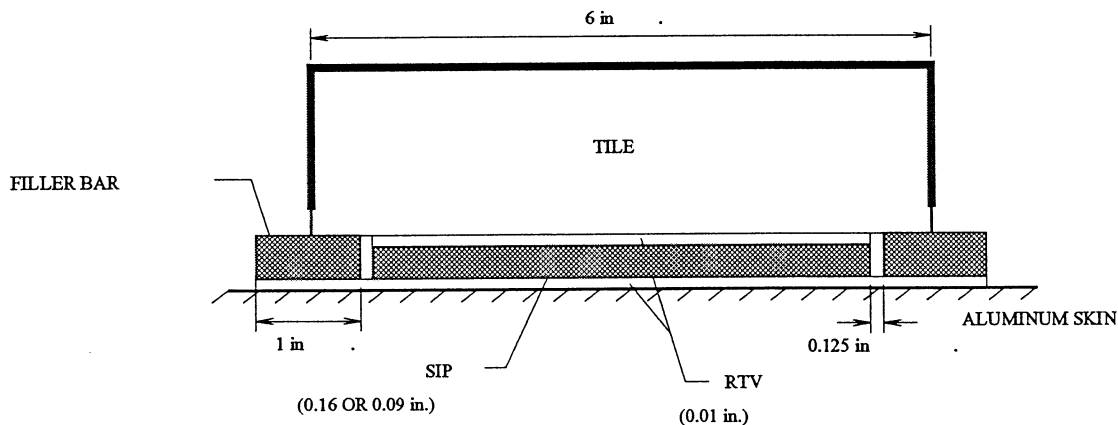
Figure 1: Single-Tile Assembly

The RSI tiles are attached to the Orbital Vehicle via a strain isolation pad (SIP) and two layers of RTV glue as shown in Figure 1. RTV has an installed thickness of 0.01 inches. There are two different thicknesses of SIP used on the Orbital Vehicle, 0.09 and 0.16 inches, each having different material properties. Also, filler bar, which is made of material identical to that of the SIP, is placed below the gap of adjacent tiles. It is important to note that the filler bar is bonded only to the structure, not to the tile; the contact at this interface is caused only because the filler bar is in slight compression when installed. Material properties of the RTV and SIP are also given in Table 1.

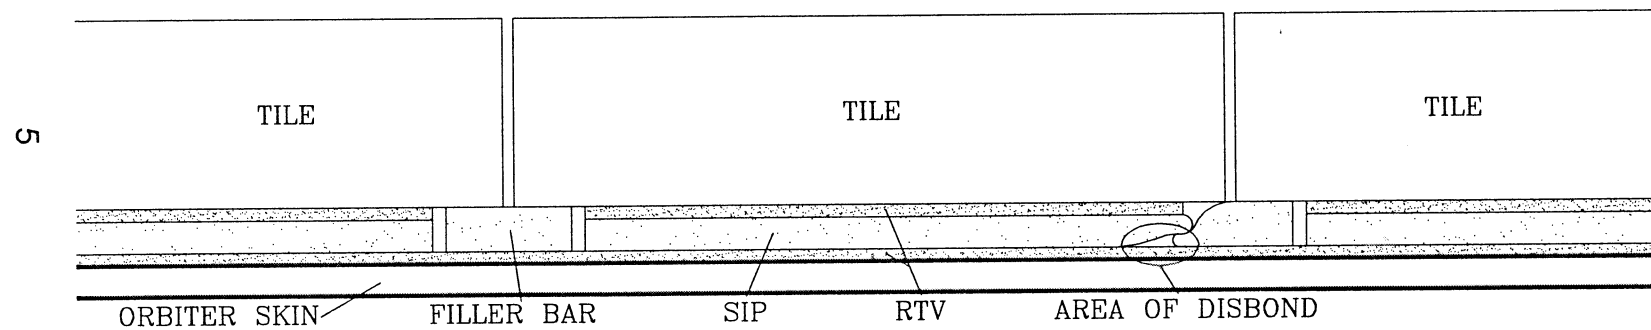
Figure 2: Disbond due to Physical Interference between SIP and Filler Bar

A loss of bond of the tile assembly can be caused by a variety of reasons. Deterioration of the RTV over time is one possible cause. Another is poor installation of the tile assembly, where possibly there is physical interference between the SIP and the filler bar (see Figure 2). Whatever the cause of disbond, NASA has found that the highest occurring and most likely location of disbond is along any of the edges of the SIP between the SIP and the Space Shuttle skin. Thus, for analyses in this report, disbond is assumed to occur at this location.

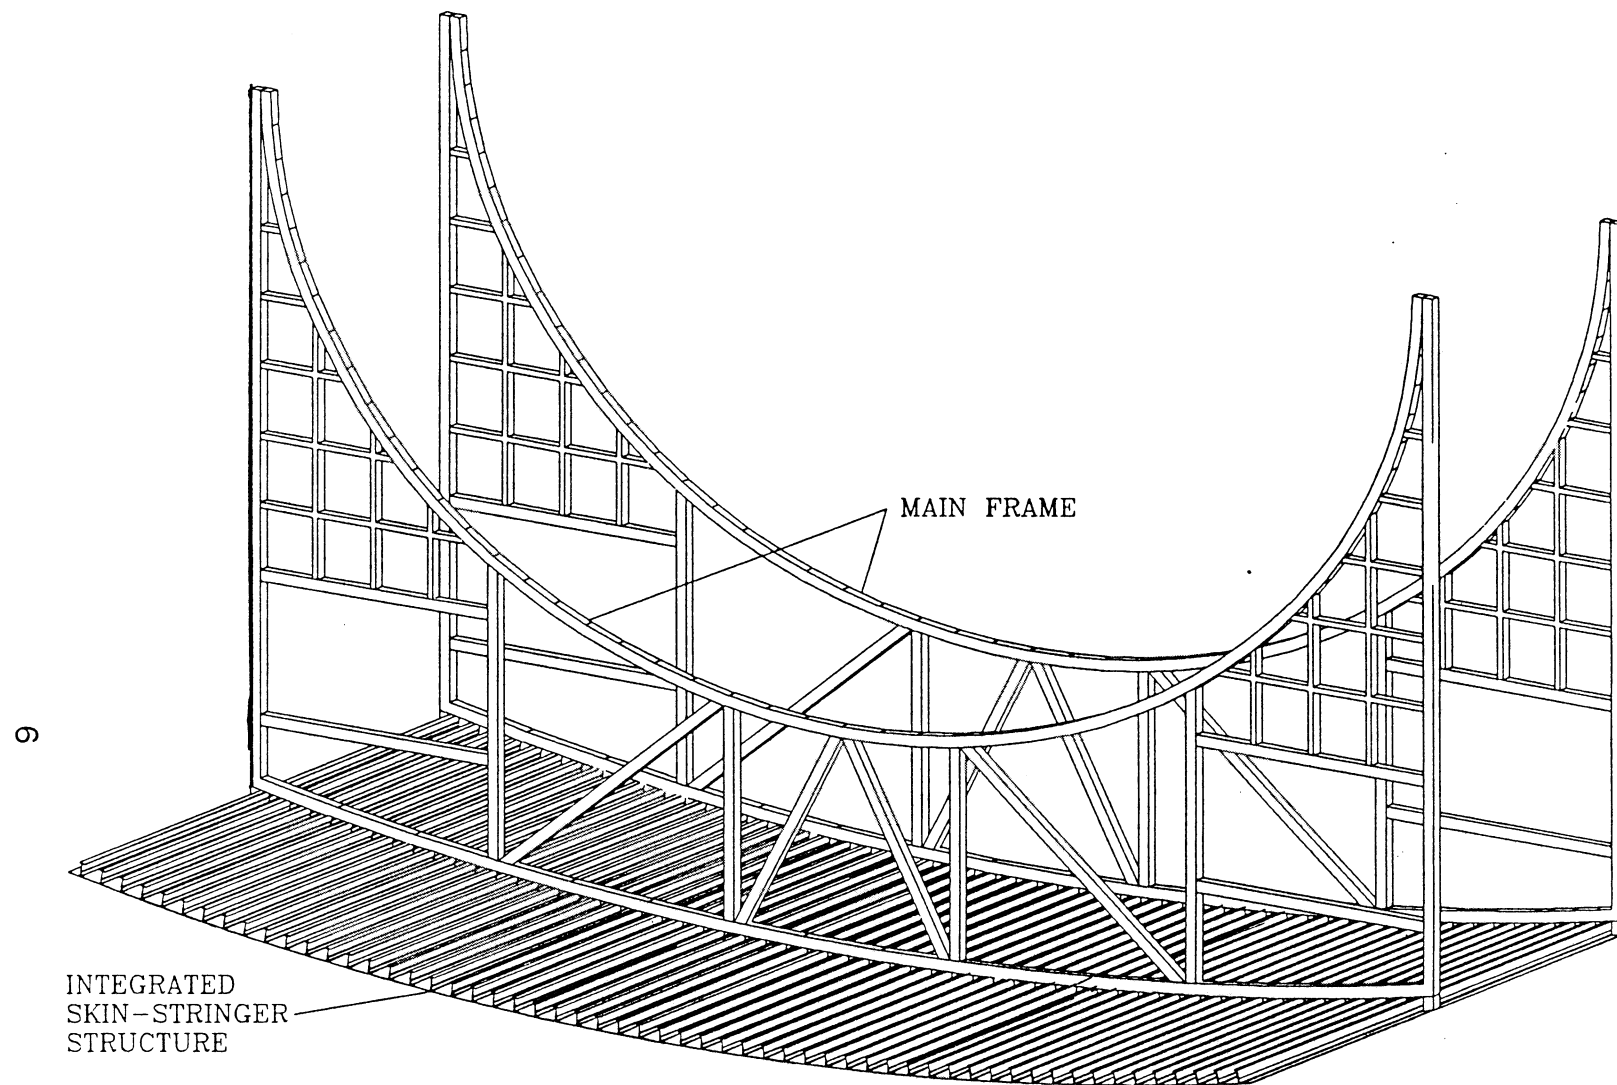
Figure 3: Mid-Fuselage Structure Section

The skin structure of an Orbital Vehicle is made of aluminum and varies at different sections of the vehicle. For instance, at the mid-fuselage, an integrated skin-stringer structure is used, while in the aft-fuselage, a very dense machined grid structure is utilized. Obviously, the choice of structure is independent of the tiles, but rather is based upon loading conditions exerted on the Orbital Vehicle. Thus, the structure below a tile is different at different sections of the Orbital Vehicle. An illustration of the skin structure at the mid-fuselage is given in Figures 3 and 4.

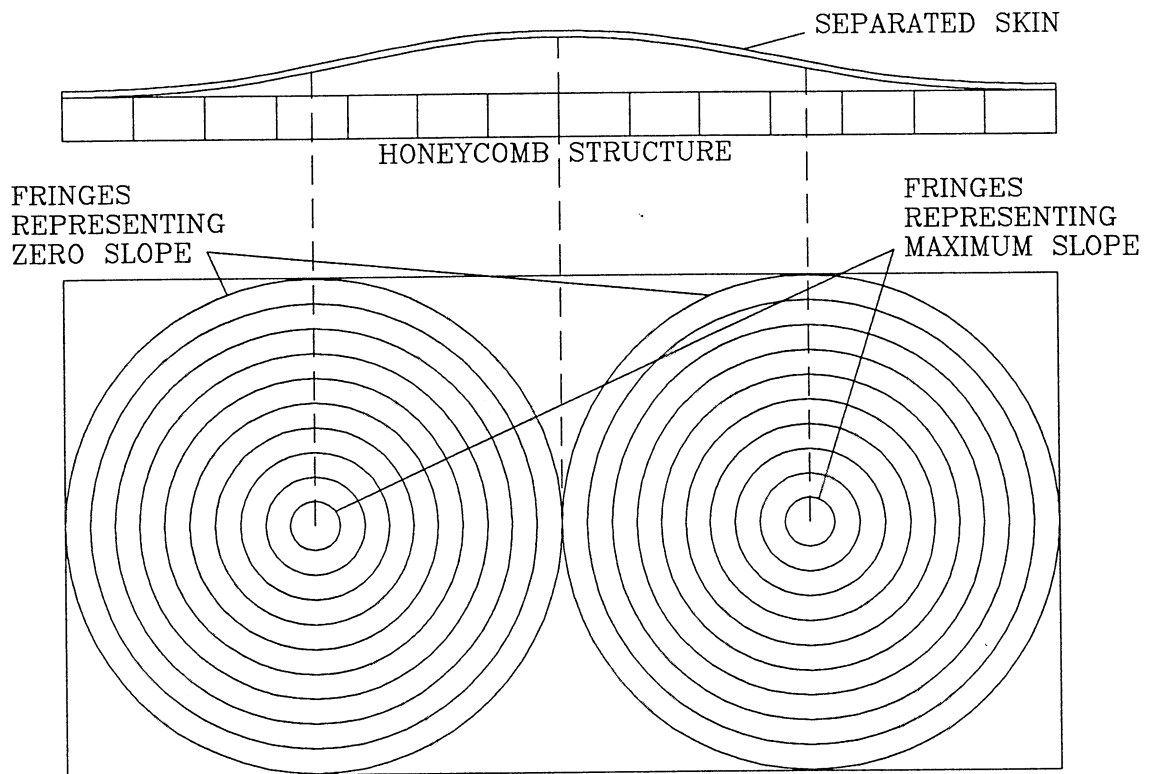
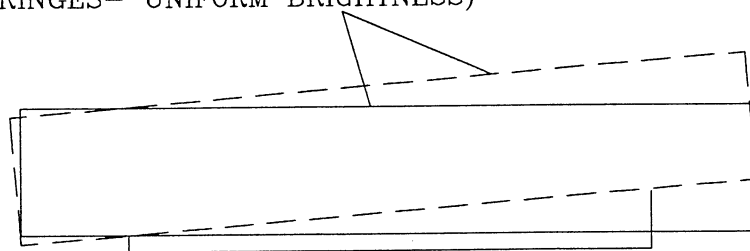
Figure 5: Shearography

SCHEMATIC OF FRINGE CONTOURS REPRESENTING
CONSTANT SLOPE OF OUT-OF-PLANE DISPLACEMENTS

CONSTANT SLOPE
(NO FRINGES- UNIFORM BRIGHTNESS)

SCHEMATIC SHOWING ROCKING MOTION OF TILE

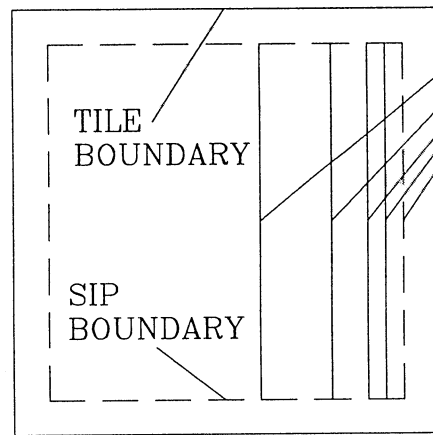
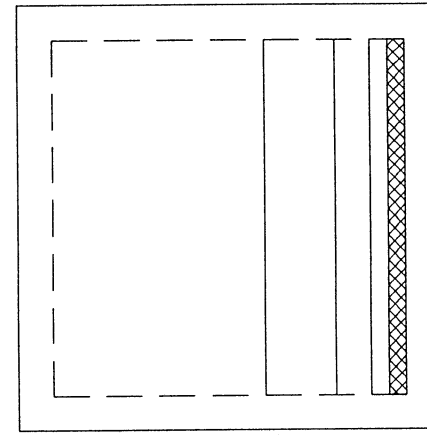
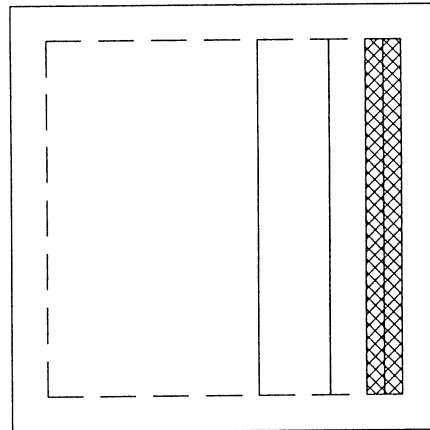
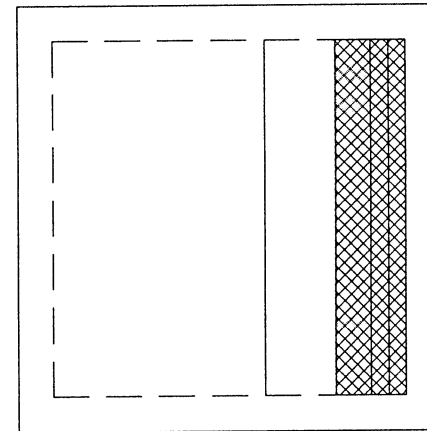
Figure 7: Disbond Areas and Required Lines of Nodes

LINE OF NODES REPRESENTING
POSSIBLE DISBOND BOUNDARIES

100% BOND

95% BOND

90% BOND

80% BOND

The most important variable to be modeled is the amount of disbond associated with a tile. For the finite element analyses performed, bond conditions of 100%, 80%, and 60% were modeled. Disbond was modeled along an edge parallel to the Roll axis of the tile assembly in all models unless noted otherwise.

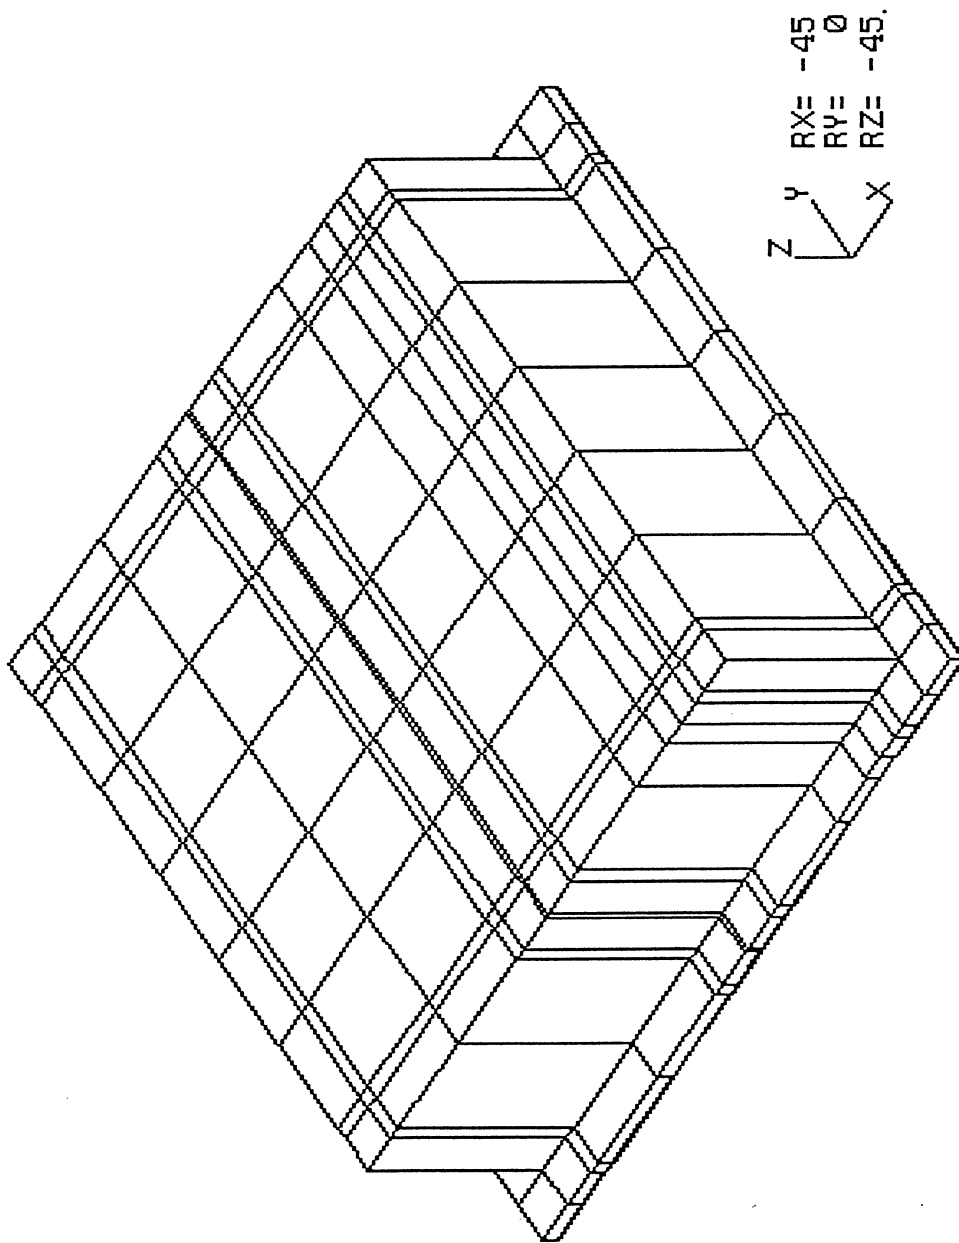
Figure 14: STA00F.EII

The first finite element analyses were performed to demonstrate the affect of disbond on natural frequencies. The FE model used was of tile# 191025-299 from OV-102 with filler bar mounted on a clamped structure. Figure 14 illustrates the mesh of this model. The 100% bond case model has 2640 degrees of freedom (DOF) and 528 elements and used 7 minutes of CPU time. Referring to Table 3 and Figure 15, it is noted that natural frequencies for all modes drop with an increase of disbond. Knowledge beforehand of these numbers would enable a test engineer to accurately quantify the amount of bond for this particular tile from modal test data. In addition, the location of disbond could be determined upon observation of the tile mode shapes as illustrated in Figures 16, 17, and 18. The tile mode shape which is most affected by the change in stiffness is the rocking mode about the axis parallel to that of the disbond. In this case, mode# 5 for the 80% and 60% bond cases demonstrates the most dramatic change. Note that the rocking motion in the 100% case is symmetric about the center of the tile. In the 80% and 60% bond cases, the axis of rotation is shifted away from the area of disbond such that the tile above the area of disbond undergoes increased motion. The line of zero motion (the rotation axis) is a clear indicator of the location of disbond. This particular model is of a single-tile assembly with filler bar and a clamped structure assumption, however the decrease in natural frequencies and shifts in mode shapes exist for all tile assembly FE models.

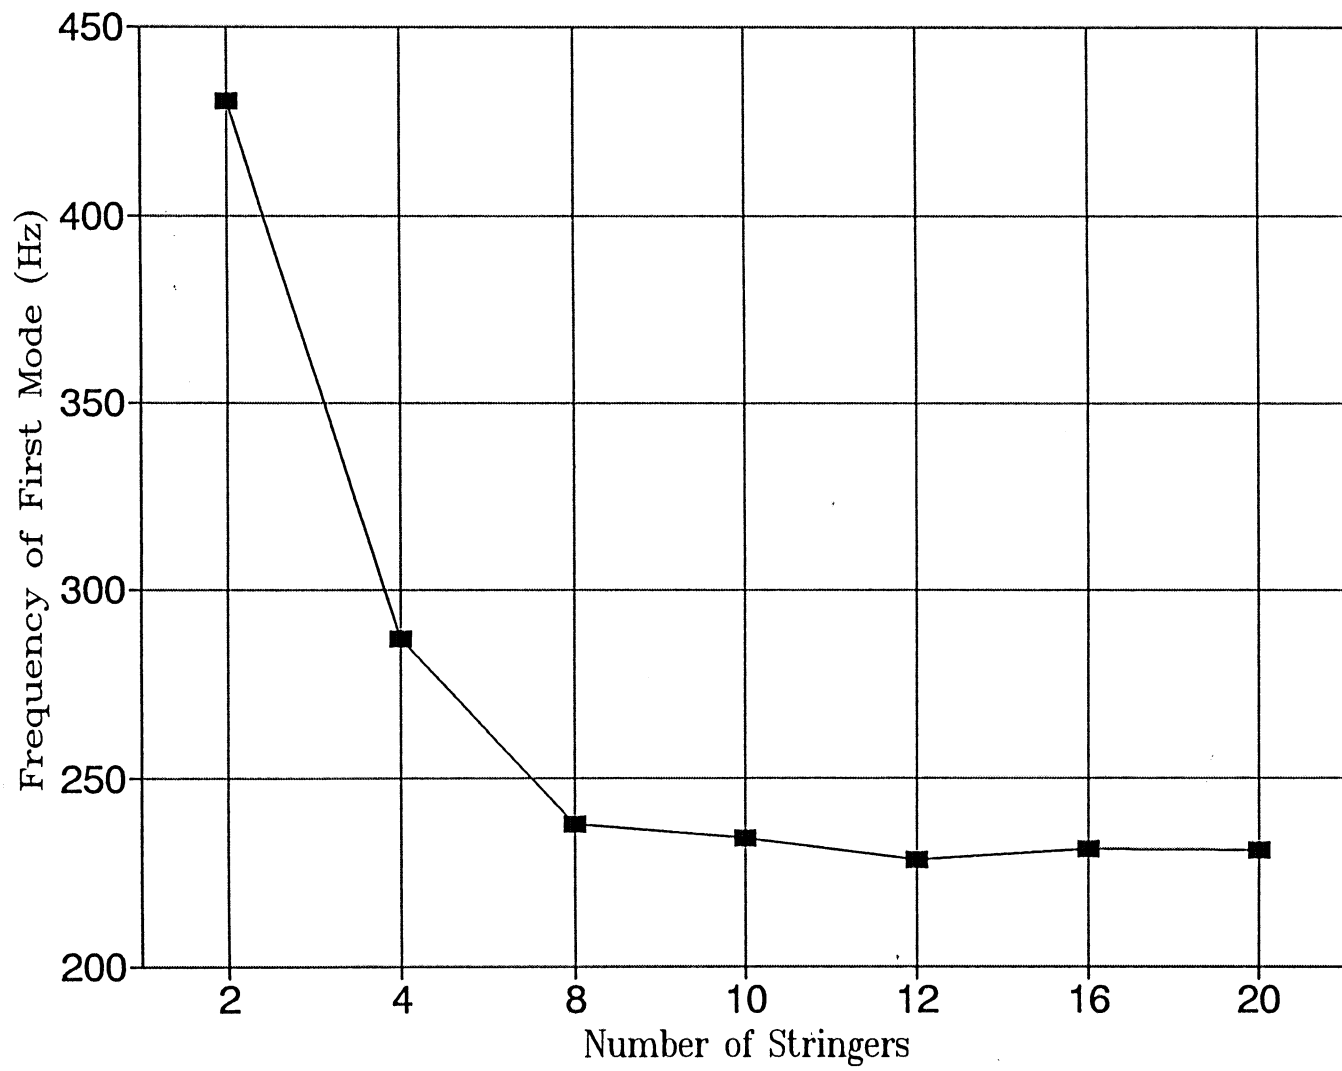
Figure 19: Mid-Fuselage Stringer Sensitivity

FEA of the structure only was performed with the structure varying in width from 2 to 20 stringers. Model size varied, obviously, with the number of stringers modeled (5256 DOF & 360 elements for 8-stringer model). However, CPU time required was no more than 10 minutes. Results of the first natural frequency (out-of-plane flexing) are presented in Figure 19. A typical mode shape (for an 8-stringer model) is shown in Figure 20. These results determined thenumber of stringers to be used for tile/extended structure models. Upon analysis of the results, it was noted that the first natural frequency did not significantly vary with more than 8 stringers, hence 8 stringers were used in extended structure modeling.

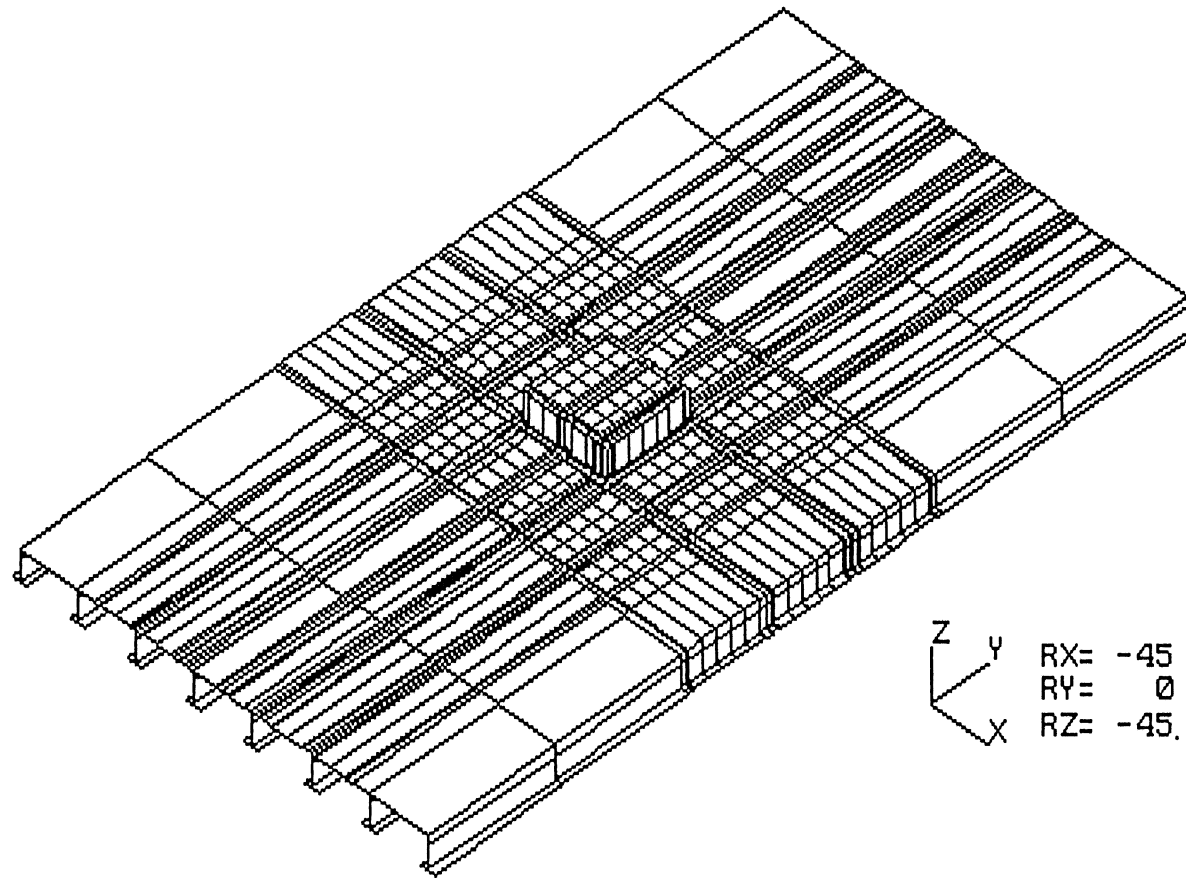
Figure 21: STA00P.EII

Next, tile# 191025-299 with filler bar on extended structure was modeled (see Figure 21 for mesh). The 100% bond case model possesses 18330 DOF and 3135 elements, and

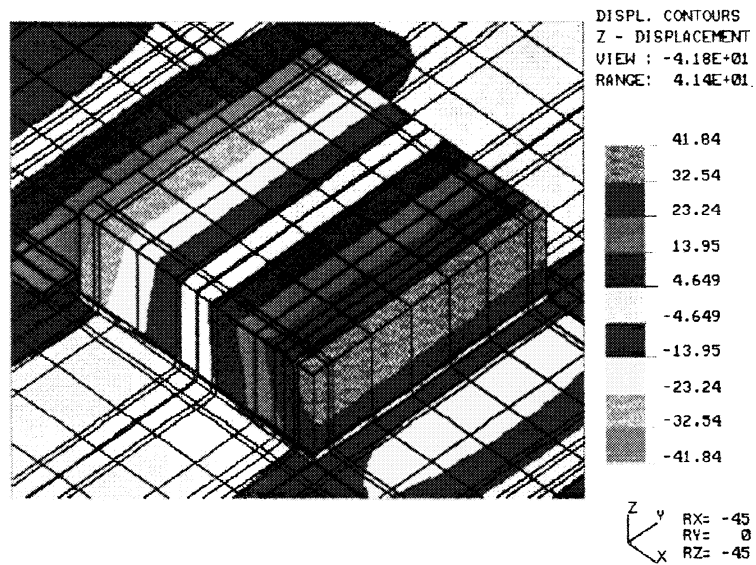
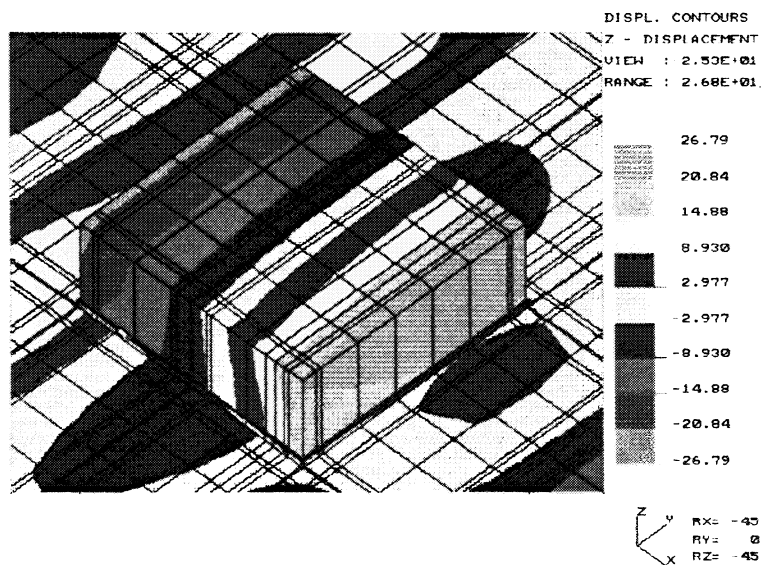
Figure 22: STA00P.EID

took 12.9 hours of CPU time to complete. FEA results are given in Table 5. Figures 22 and 23 illustrate the rocking mode shape of the tile for the extended structure model for the 100% and 80% bond cases, respectively. It was expected that natural frequencies of this model would be lower than those of the single-tile/clamped structure model as a decrease in stiffness of the tile assembly would result due to the introduction of an elastic structure. However, for each out of plane mode of the rigid structure case, two exist for the flexible structure, one lower and one higher than the frequency of the rigid case. Due to the structural motion, the lower frequency corresponds to where the structure is in phase with the tile and the higher frequency corresponds to where the structure is 180° out of phase with the tile. Another unexpected result is encountered in the mode shapes of this model. Whereas it has been demonstrated in a clamped structure model that the axis of rotation for the mode of tile rocking about an axis parallel to that of the disbond shifts away from the disbonded area, the axis of rotation shifts towards the disbonded area in this model. This perplexity demonstrates the need for further development of finite element models involving an extended structure, if it is deemed that structure is necessary for the correct dynamic response of a tile.

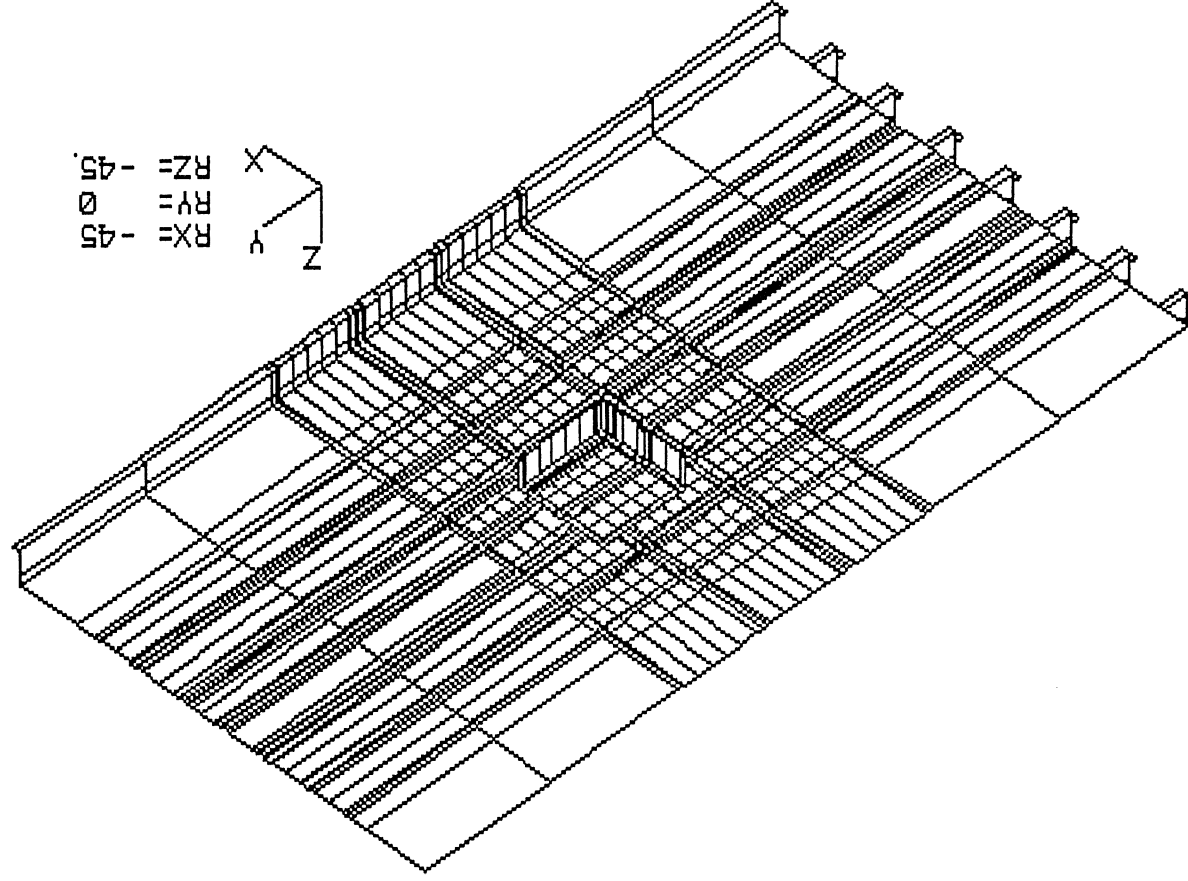
Figure 28: STA000.EII

The single-tile/extended structure model of Table 5 was modeled without filler bar (see Figure 28 for mesh) with results appearing in Table 7. Mode shape plots for 100% and 80% bond cases are shown in Figures 29 and 30, respectively.

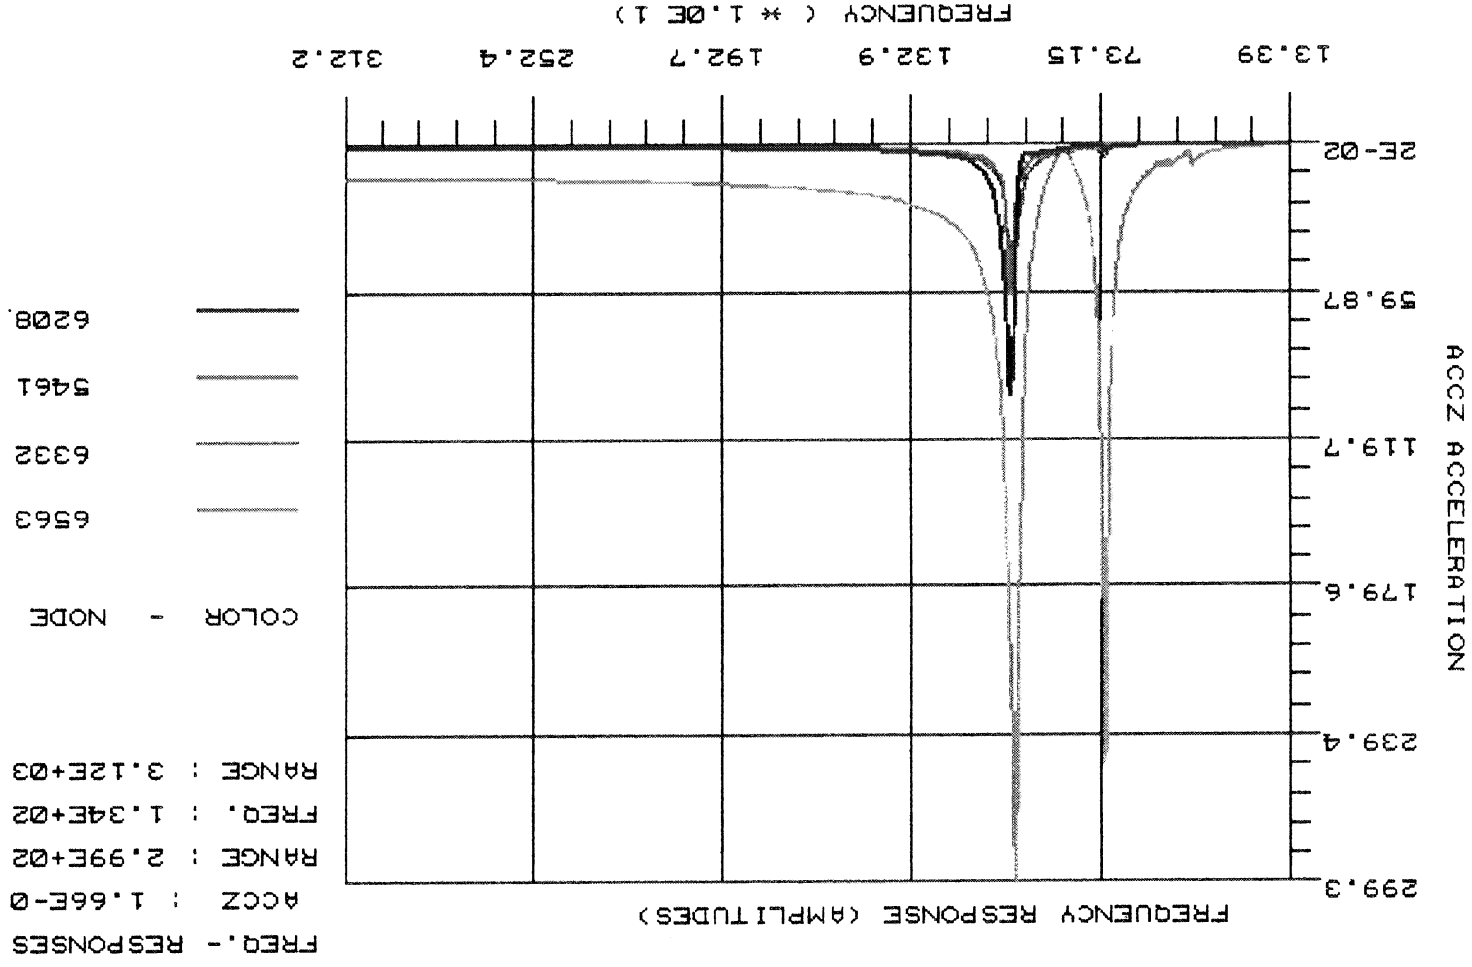
Figure 34: Typical Frequency Response Spectrum Graph of 10-Tile/Clamped Structure Model

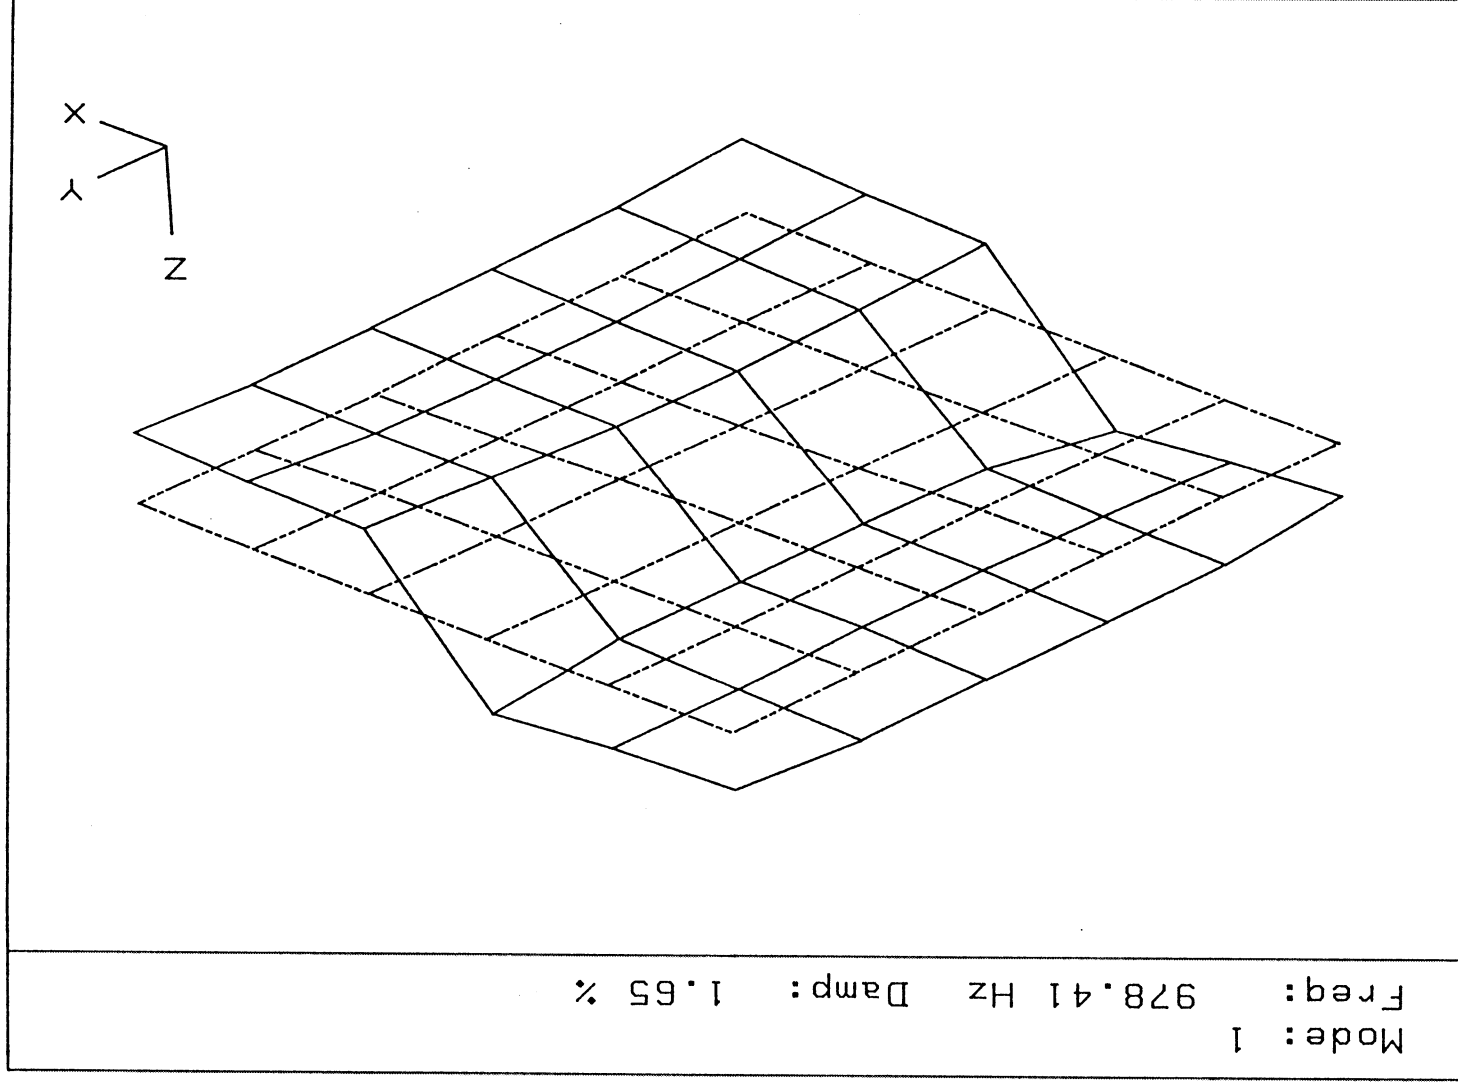
Figure 37: Ometron VPI Measured Mode Shape of Tile #191025-299

MODE #1, 978.41 Hz, 1.65% Cr
(DEFORMED-SOLID LINE, UNDEFORMED-DASHED LINE)

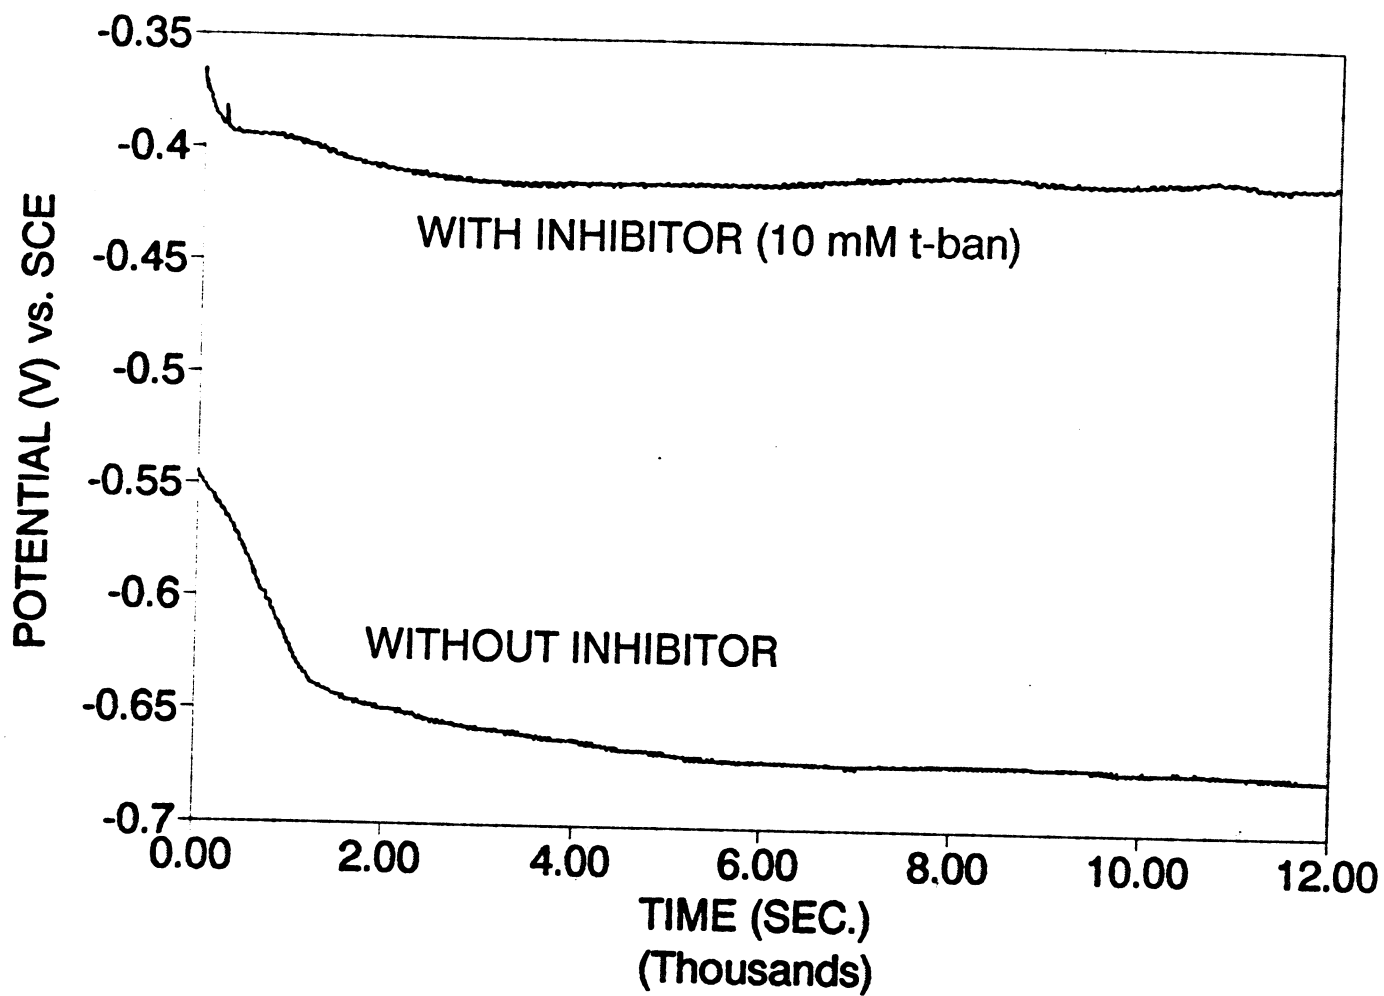
Figure 2 Showing that corrosion potential of polished rebar is about 250 mv more positive when 10mM tetrabutylammonium nitrite is added to 3.5%NaCl solution

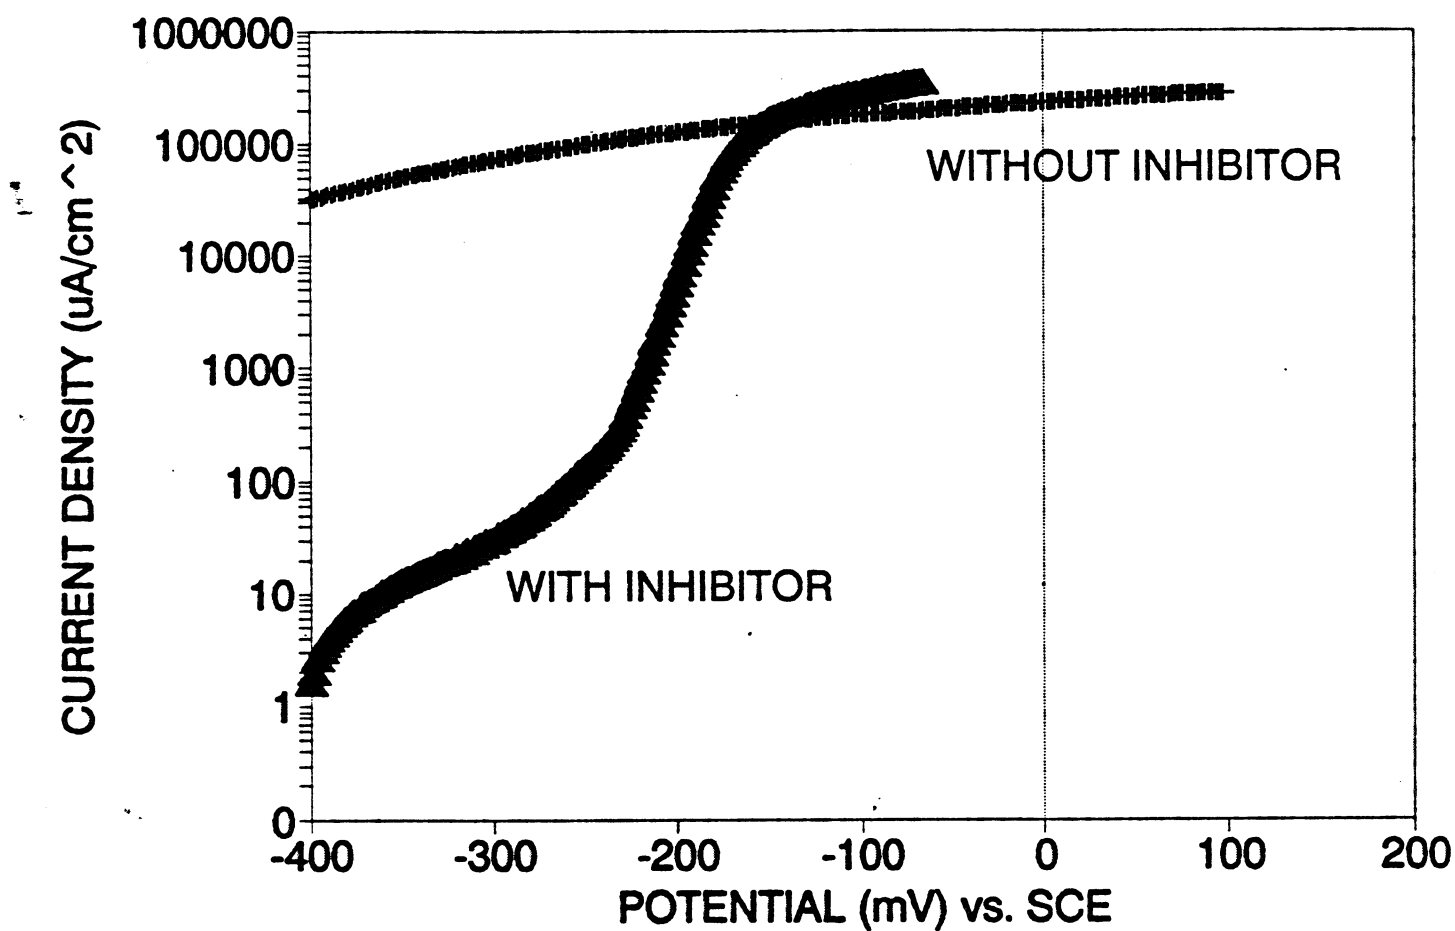
Figure 3 Shows that at all the applied potential the current density of polished rebar specimens is much lesser in the presence of 10mM tetrabutylammonium nitrite in 3.5%NaCl solution as compared to that without inhibitor

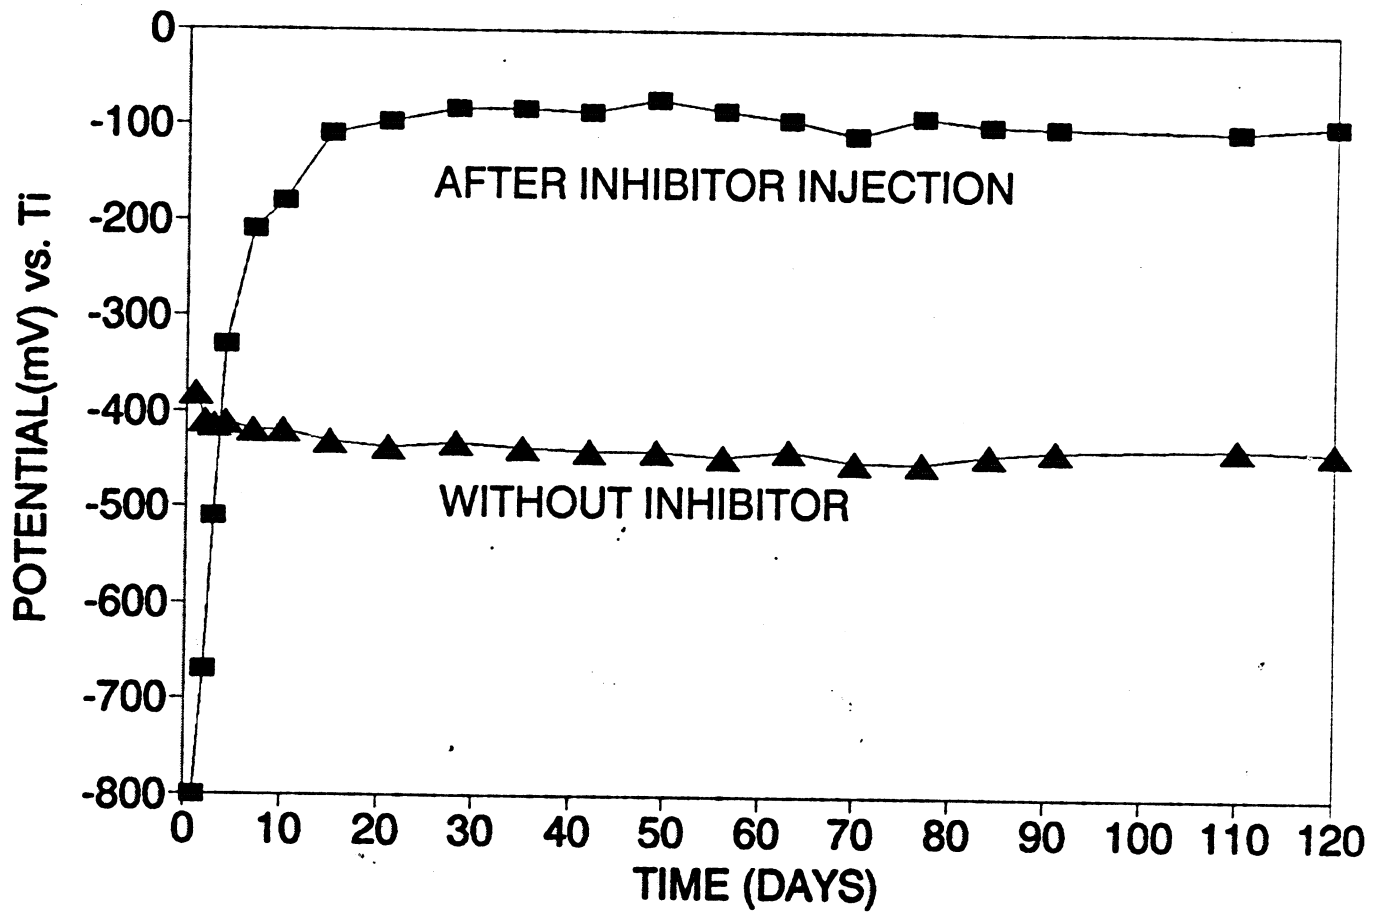
Figure 4 showing that corrosion potential of concrete specimens containing 15 lb/yd³ became about 300mV more positive after electrical injection of inhibitor (tetrabutylammonium nitrite) for one week

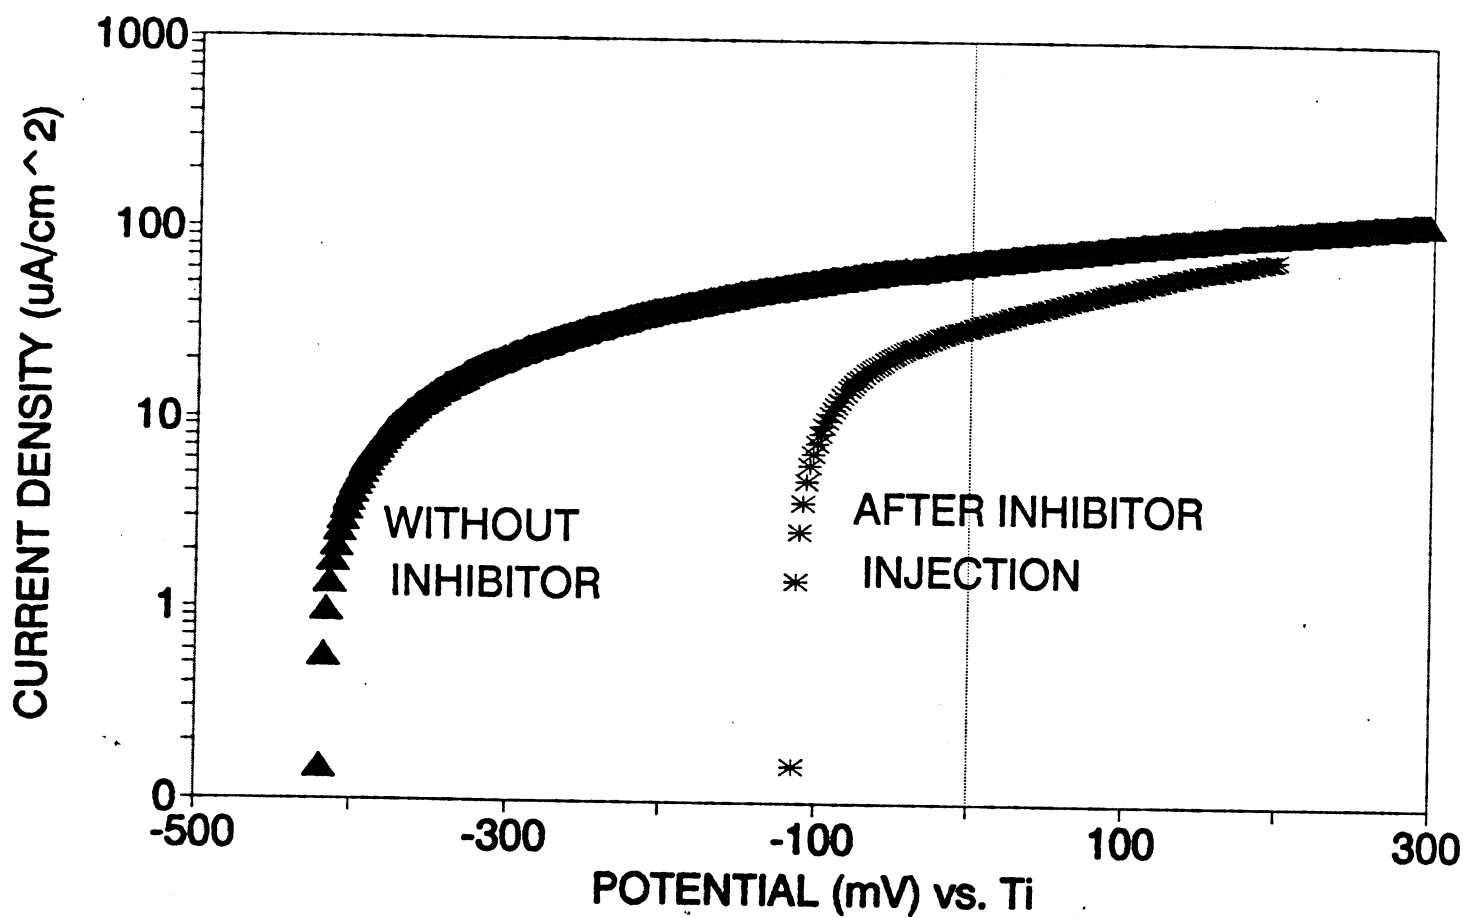
Figure 5 Potentiodynamic polarization curves showing that current density for concrete specimens containing 15 lb/yd³NaCl after electrical injection of tetrabutylammonium nitrite for one week is much lower than that without any inhibitor addition

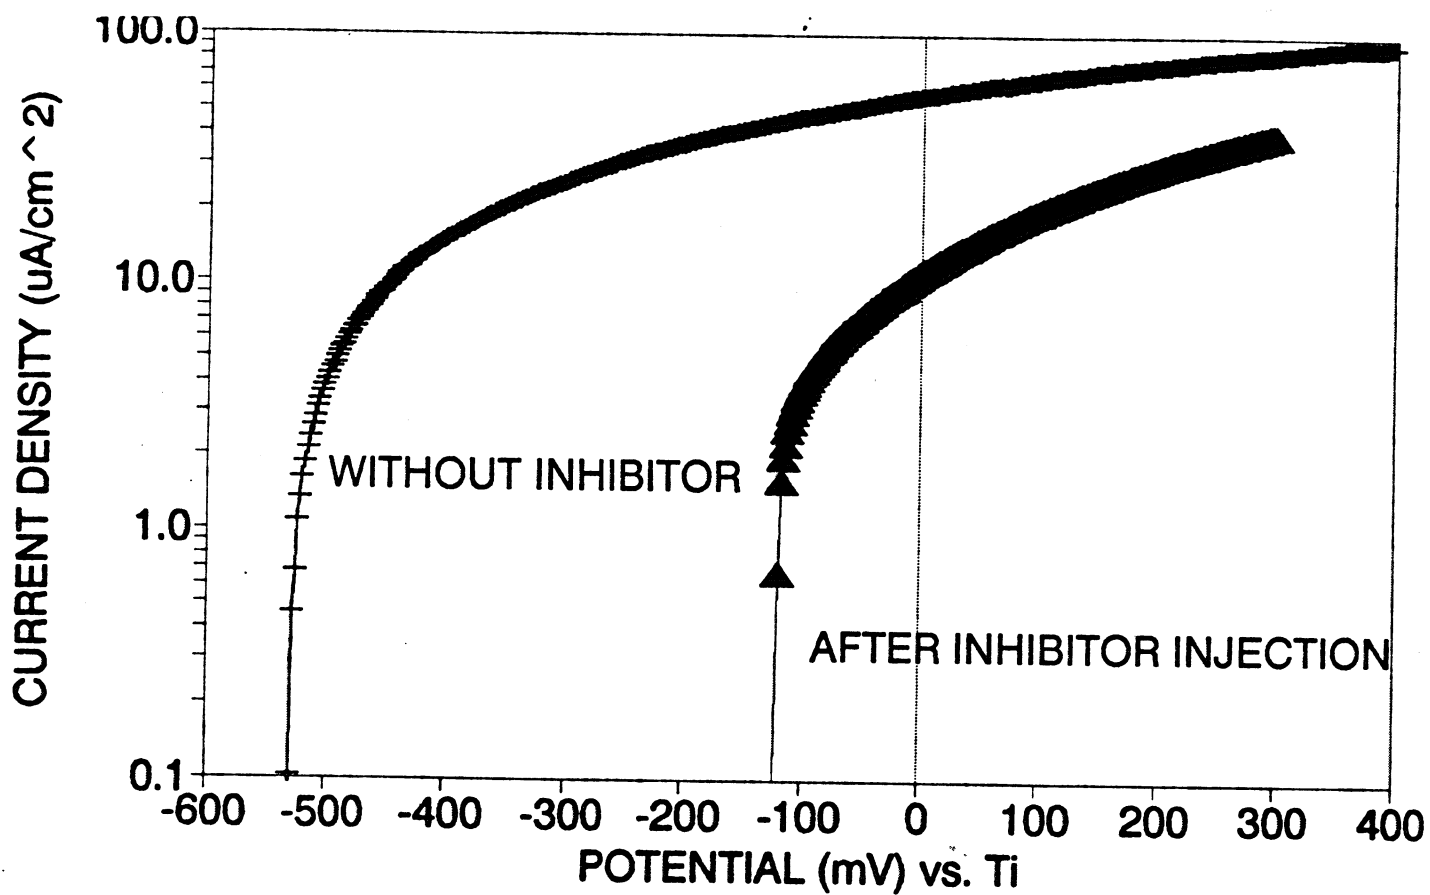
Figure 6 Potentiodynamic polarization curves show that the lower current density for concrete specimens containing 20 lb/yd³NaCl after electrical injection of tetrabutylammonium nitrite for one week
